## Case Study – Belzona coating of Landia Chopper pump wear components

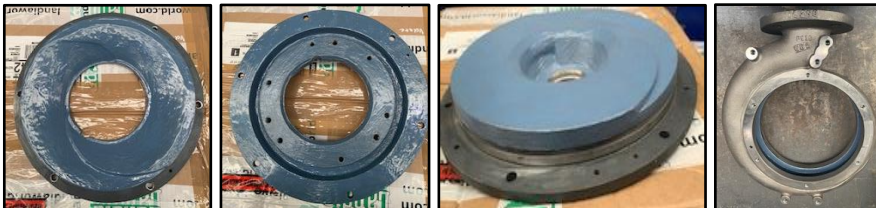
Severn Trent free issued new Landia wear components consisting of Front wear plate, Back wear plate and Volute casing, Grit blasted new components to achieve correct surface profile in line with SA2.5 Applied Belzona 1321 Abrasive Resistant coating.
