**HAYLEY 24/7 DEXIS**

**PROVIDES SPINDLE  
STORAGE SOLUTION  
TO LEADING UK  
AUTOMOTIVE  
PRODUCTION  
FACILITY**

CS00924/7

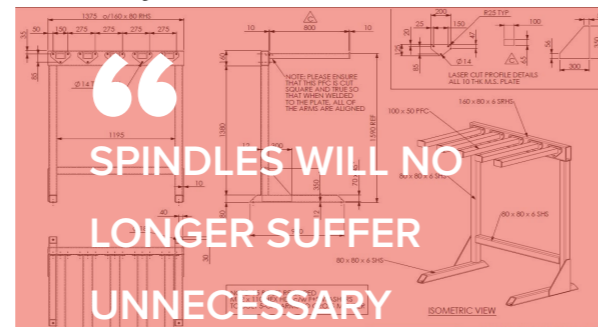
The completed rack meets the customer's bespoke requirements, providing them with a storage system that helps assure that spindles are stored correctly and safely. As a result, spindles will no longer suffer unnecessary damage due to improper storage. The solution also provides a FIFO system, to assist with asset management, and in the equal distribution of wear across the inventory.

**DAMAGE DUE TO IMPROPER STORAGE.**

The team at HAYLEY 24/7 DEXIS designed two bespoke frames, able to hold 15 spindles each. Once the design had been accepted, the frames were manufactured from mild steel materials, cut and welded under coded conditions, and plastic-coated to the clients' specifications. Also, carriers were designed and manufactured by the team, to suspend the spindles from the frame runners.

Stored spindles used in the body shop are now easily accessible to staff and can be loaded/unloaded from either side.
