CASE **STUDY**

**PUMP
REFURBISHMENTS
SET TO SAVE CAR
MANUFACTURER
£184k+ IN ANNUAL
COSTS**

HAYLEY 24/7 DEXIS MECHANICAL ENGINEERING SERVICES // AUTOMOTIVE

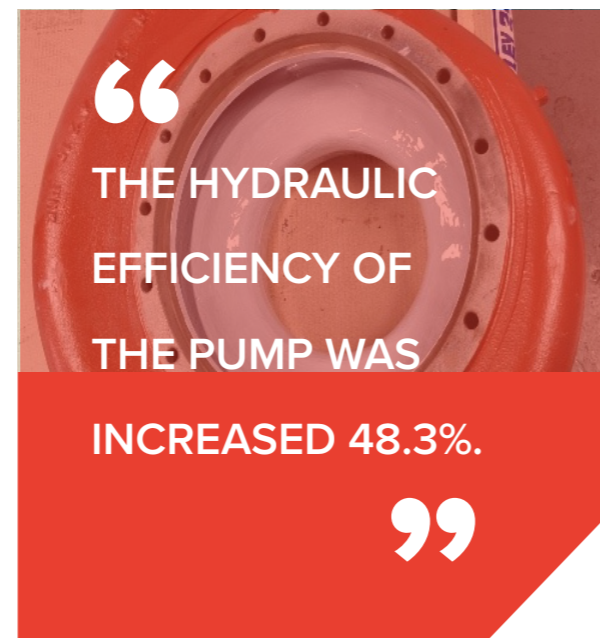
It was calculated that the refurbished pump would deliver an annual energy cost-saving of £14.5k, based on the following performance test results:

- Hydraulic efficiency: increased to 48.3%
- Flow rate: increased from 77.3% to 85.1%
- Motor absorbed power: reduced from 42.6kW to 40.8kW
- Pump differential head: increased from 20.6m to 23.5m

The customer was keen to proceed and the team set to work. This started with the heavily eroded volute casing being coated with Belzona 1111, a metal repair coating. The volute casing was then re-profiled to suit the impeller vane tips and Belzona 1341 efficiency coating was applied to improve the units' hydraulic efficiency, flow rate and head characteristics. Flow rate was an important factor in the customers' operation, and this was identified as a key metric for improvement prior to the refurbishment.

The pumps' seals were also upgraded to the latest EagleBurgmann SN Single cartridge seals, with bearing isolators installed to help

eliminate bearing contamination. Reassembly of the unit was completed, and the pump was re-tested before being shipped back to the customers' facility.
